Review of Long-Term Maintenance Plans for the South Jetty, Grays Harbor, Washington

Final report

Prepared for U.S. Army Engineer District, Seattle
Seattle, WA 98124-2255

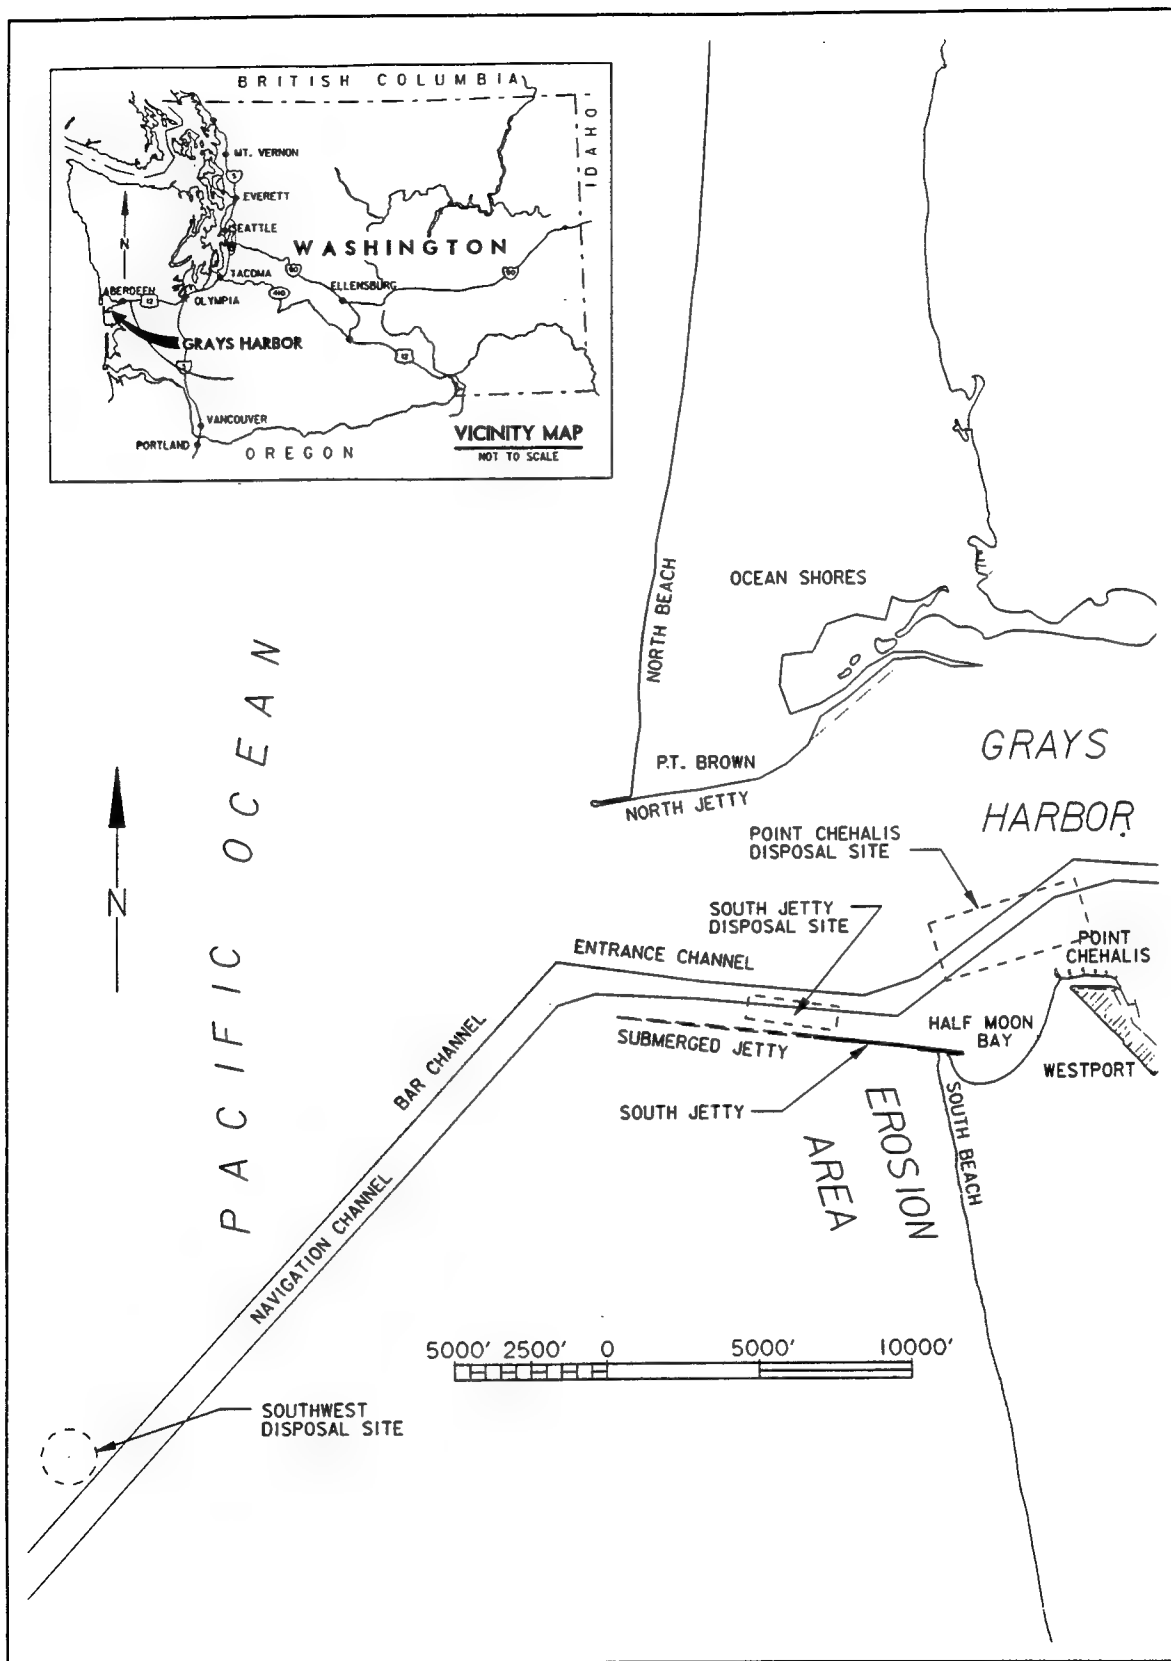
Figure 1. Grays Harbor entrance and vicinity

8. Grays Harbor entrance is located on the Washington coast about 45 miles north of the mouth of the Columbia River and 110 miles south of the entrance to the Strait of Juan de Fuca. A vicinity map and the navigation facilities in the entrance are shown in Figure 1. The Harbor broadens gradually from the river channel at Aberdeen to a large pear-shaped shallow estuary encompassing North and South Bays. An entrance is formed by sand spits extending from north and south. The Harbor is about 11 miles wide near the entrance and extends about 15 miles from Aberdeen to the entrance. The water surface of the shallow Harbor is 91 square miles at mean higher high water and 38 square miles at mean lower low water.

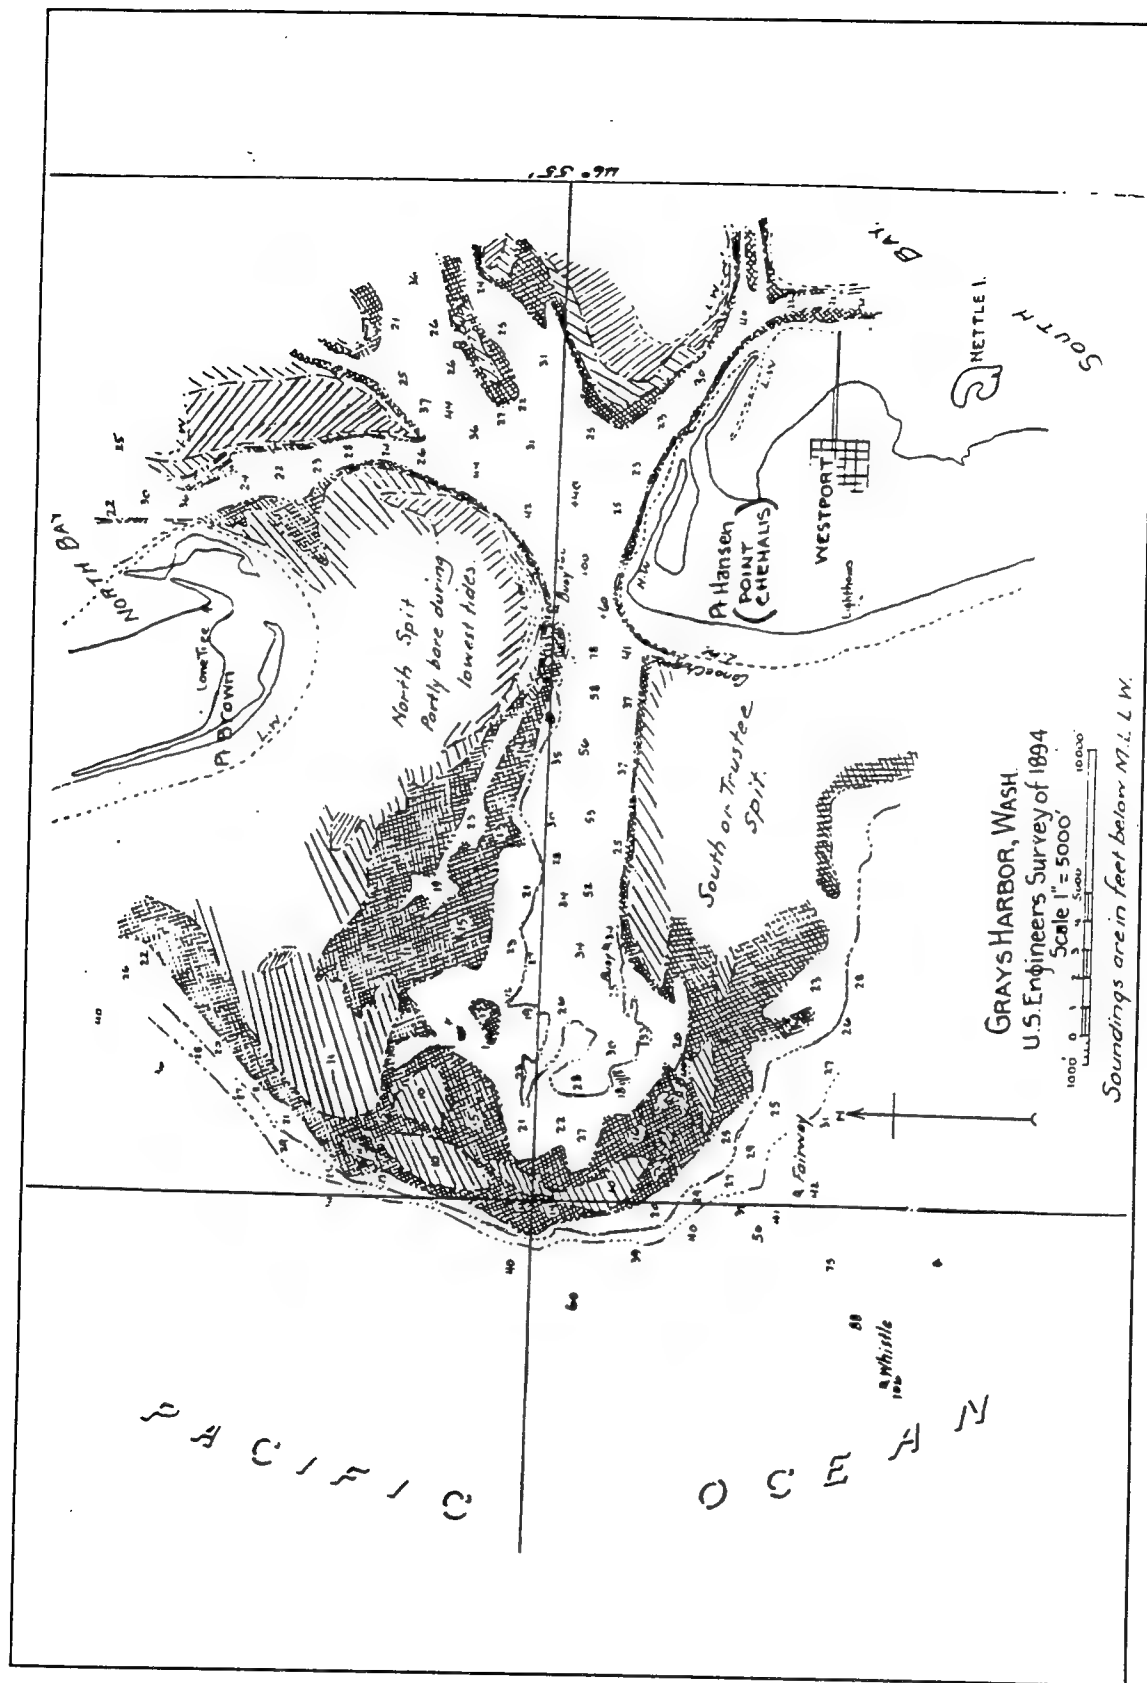
Figure 2. Entrance configuration before jetty construction

9. The configuration of the entrance in 1894, prior to construction of jetties, is presented in Figure 2. A deep entrance channel is shown in the figure. This channel was maintained by strong ebb currents resulting from constriction of tidal flows by sand encroaching from both north and south. An outer bar and deposits inside the entrance formed where ebbing and flooding tidal current velocities slowed. This figure is a "snap-shot" of a very dynamic natural entrance that changed its configuration with changing wind, wave, and sediment supplies. Shifting sands and shallow water at the outer bar created severe hazards to navigation, including grounding of ships and steepened wave conditions. Construction of jetties to stabilize the position of the entrance channel, to provide a protected entrance, and to create eroding currents at the outer bar began in 1898 and were completed in 1916. Alignments of the jetties are shown in Figure 3.

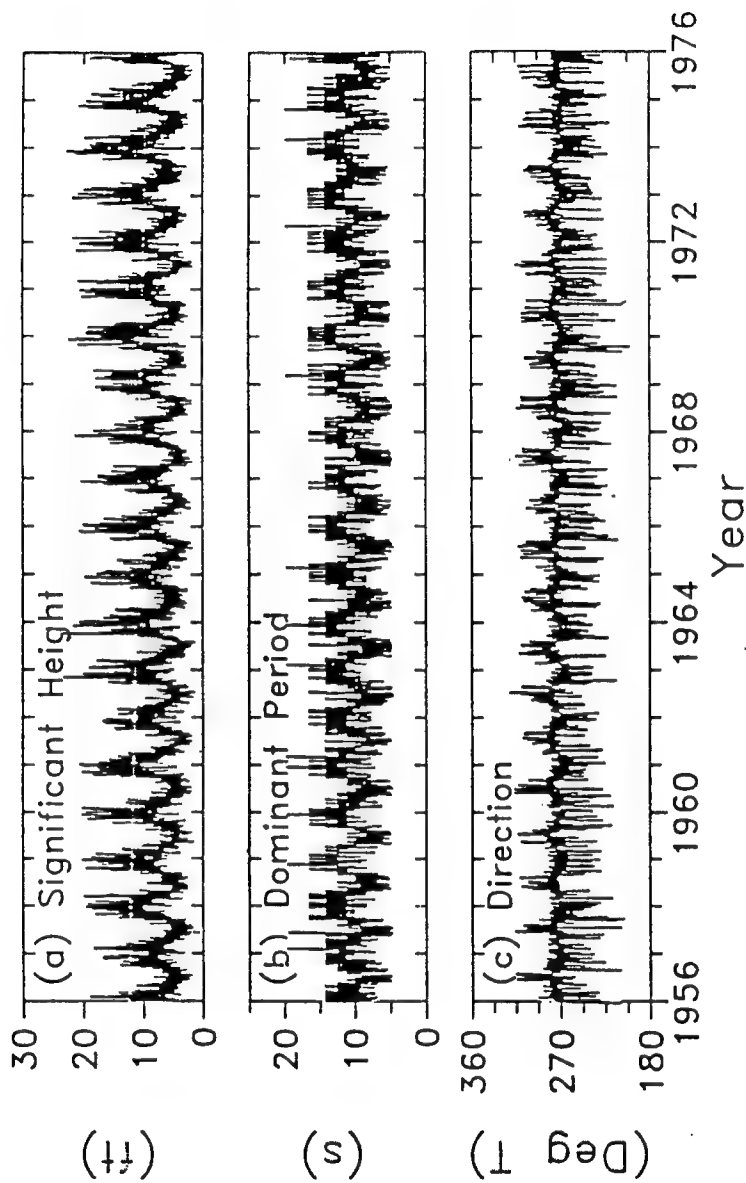
Figure 11. Hindcast wave data for WIS station 16 (from Battelle/Marine Sciences Laboratory 1992)

25. Time series of wave height, period, and direction obtained from the Wave Information Studies (WIS) by the USACE Coastal Engineering Research Center (Jensen, Hubertz, and Payne 1986) are plotted in the Battelle report (Battelle/Marine Sciences Laboratory 1992, p 42) and are shown in Figure 11. This figure shows that winter waves having significant heights on the order of 20 ft and significant periods of 16 seconds approach the entrance from the southwest to west directions. Summer waves have significant heights on the order of 4 to 5 ft, periods of 5 seconds, and approach from west to northwest.

Time Series of Wave Information Studies Wave Model Hindcasts for Station 16 at 3-h Intervals from 1956 to 1976. (a) Significant wave height, (b) dominant wave period, (c) average wave direction.

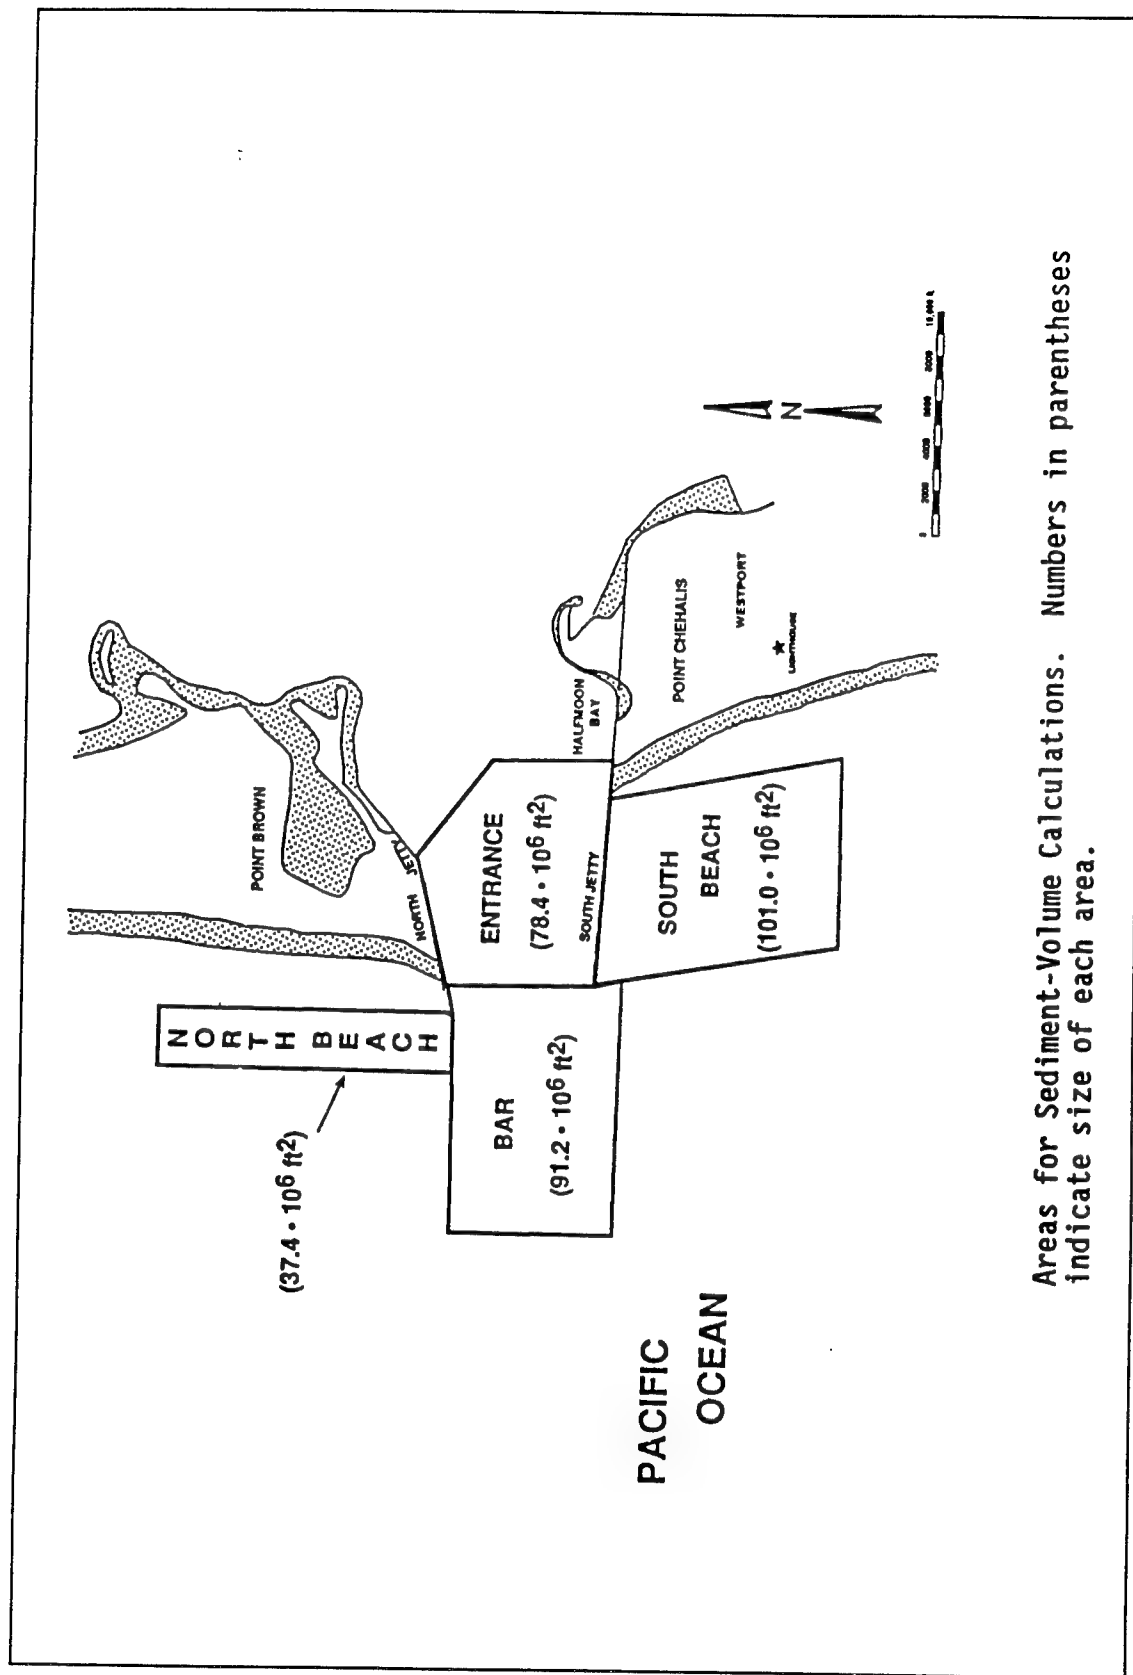
Figure 12. Areas selected for evaluation of volume changes (from Battelle/Marine Sciences Laboratory 1992)

Areas for Sediment-Volume Calculations. Numbers in parentheses indicate size of each area.
